**OHIO RIVER BASIN  
UNNAMED TRIBUTARY TO HARMON CREEK, WASHINGTON COUNTY  
PENNSYLVANIA**

**PHASE I INSPECTION REPORT  
NATIONAL DAM INSPECTION PROGRAM  
PACW31-FO-C-0025**

**July 1980**

PA 480, Washington County, Pennsylvania  
NDI No. PA 01125, PennDER No. 63-84, SCS No. PA 480  
Unnamed Tributary to Harmon Creek  
Inspected 27 March 1980

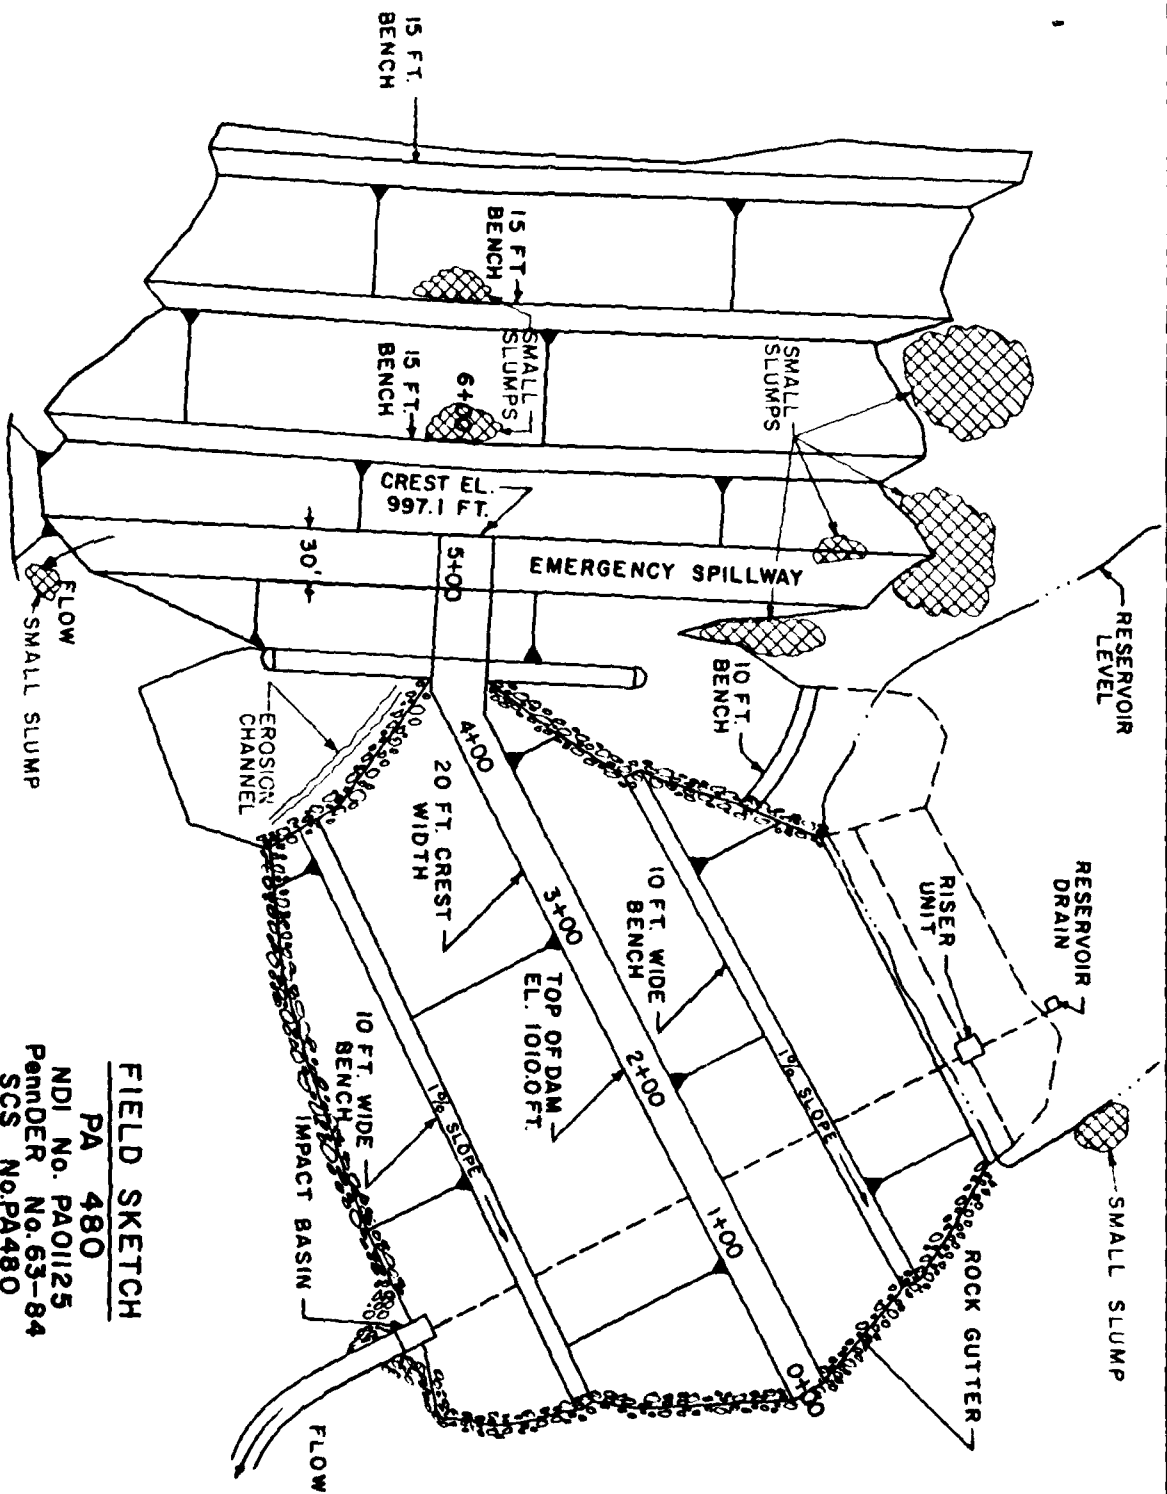
FIELD SKETCH

VISUAL EXAMINATION OF	OBSERVATIONS	REMARKS OR RECOMMENDATIONS
CONDITION (OBSTRUCTIONS, DEBRIS, ETC.)	<p>There is a one-lane bridge providing access to the dam over the downstream channel approximately 200 ft. downstream from the dam. Two 48 in. C.M.P.'s carry flow under the bridge. There are also two railroad lines approximately 2000 ft. downstream from the dam. The railroad lines are on embankments which are approximately 30 ft. high. Flow under the embankments is carried by a 5 ft. by 5 ft. box culvert.</p>	
SLOPES	The slope of the downstream channel is moderate.	
APPROXIMATE NO. OF HOMES AND POPULATION	<p>The closest homes are 6000 ft. downstream from the dam. Loss of life in these structures is not believed to be likely. There would be some economic damage to these homes.</p>
